Ice/Frost/Debris Assessment For Space Shuttle Mission STS-27R

(NASA-TM-102144) ICE/FROST/DEBRIS
ASSESSMENT FOR SPACE SHUTTLE MISSION
STS-27R, DECEMBER 2, 1988 (NASA) 200 p
CSCI 22B

ICE/FROST/DEBRIS ASSESSMENT
FOR
SPACE SHUTTLE MISSION
STS-27R
DECEMBER 2, 1988

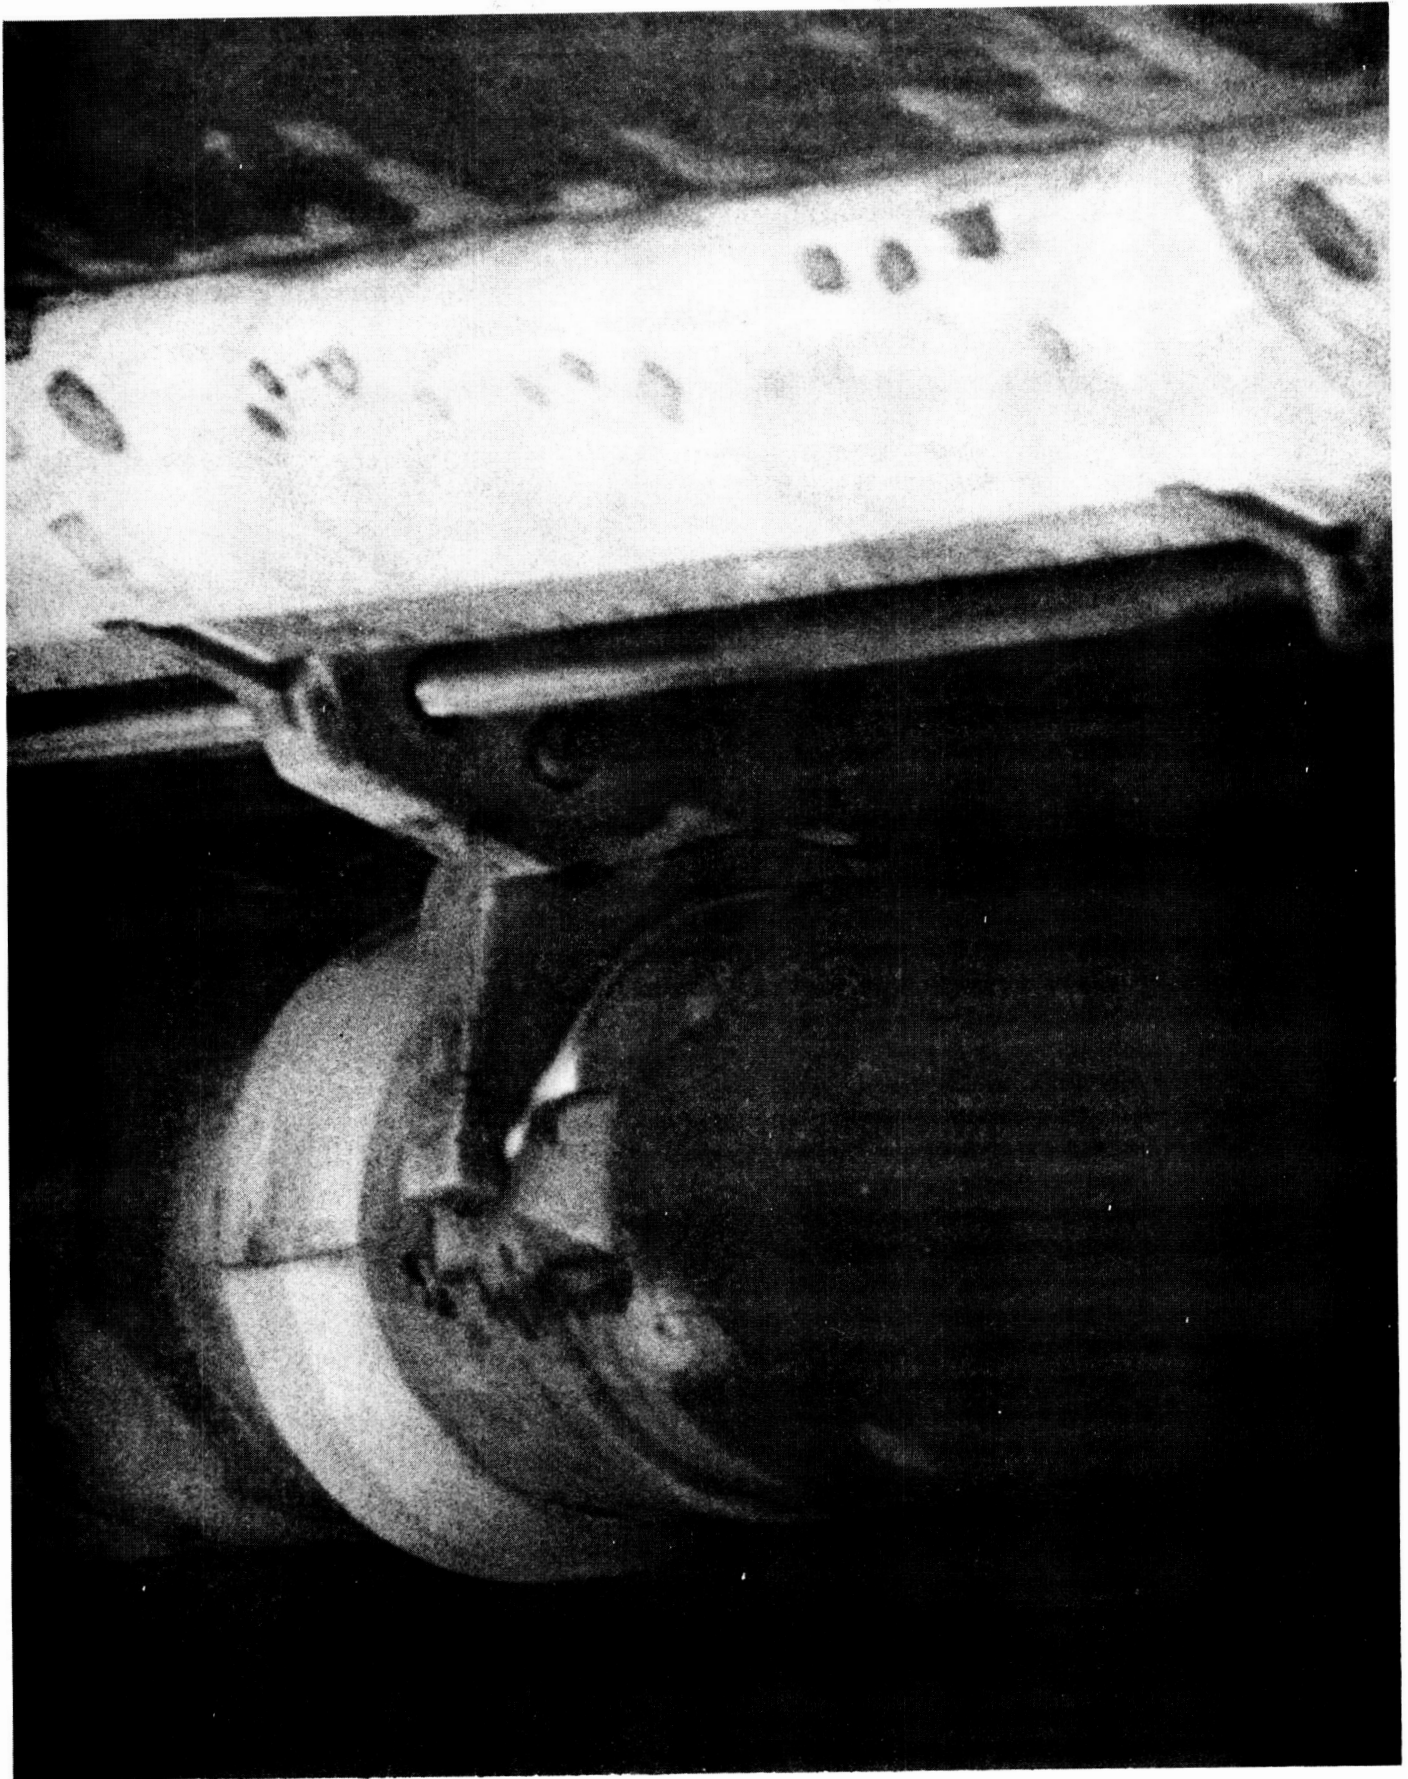
ICE/FROST ACCUMULATION IN LO2 FEEDLINE SUPPORT BRACKET XT 1377

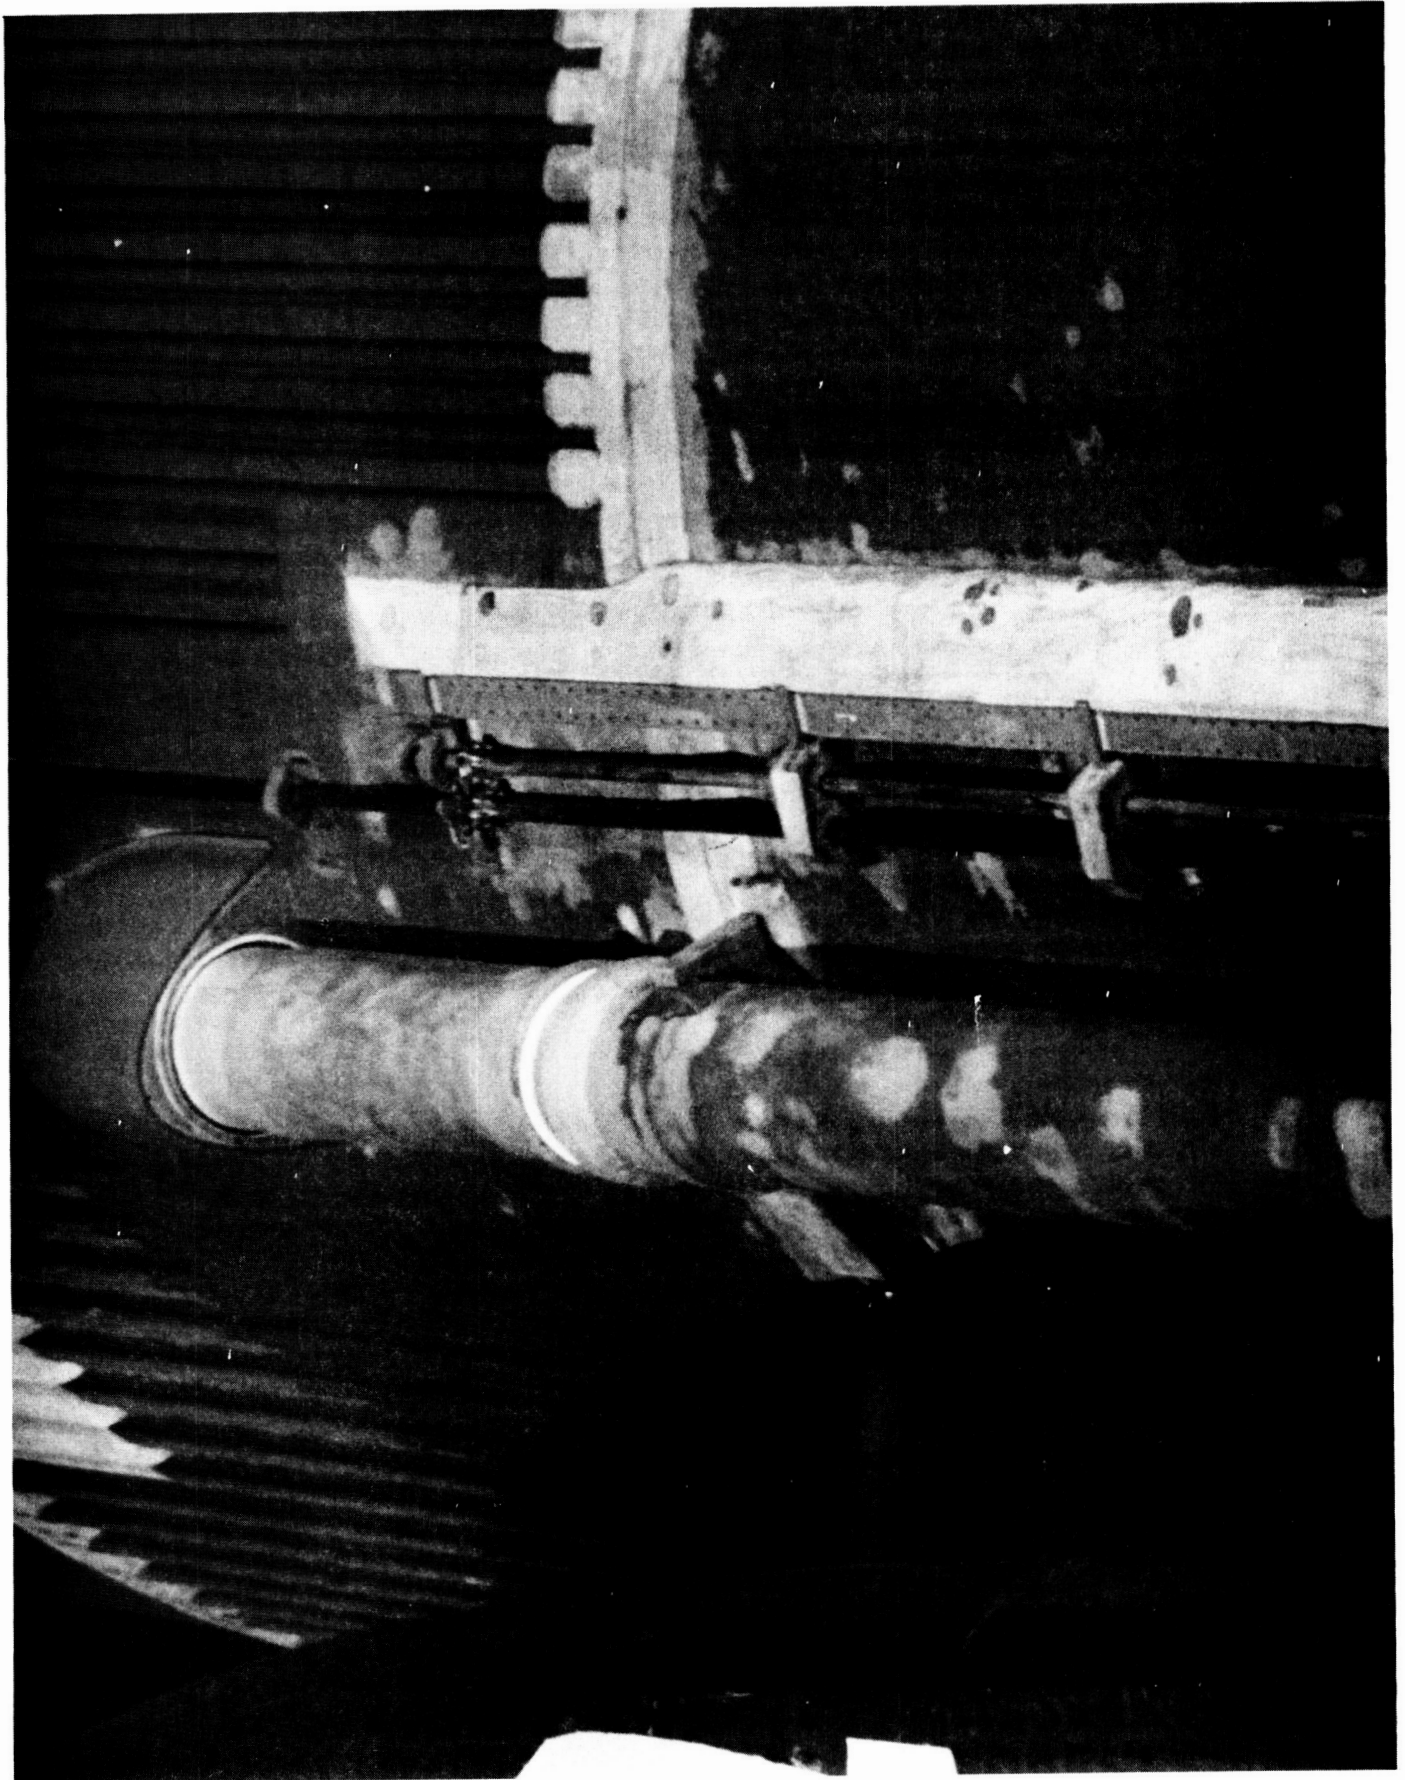
UPPER LO2 FEEDLINE. TYPICAL ICE/FROST ACCUMULATION
IS VISIBLE IN FEEDLINE BELLOWS AT XT 1106

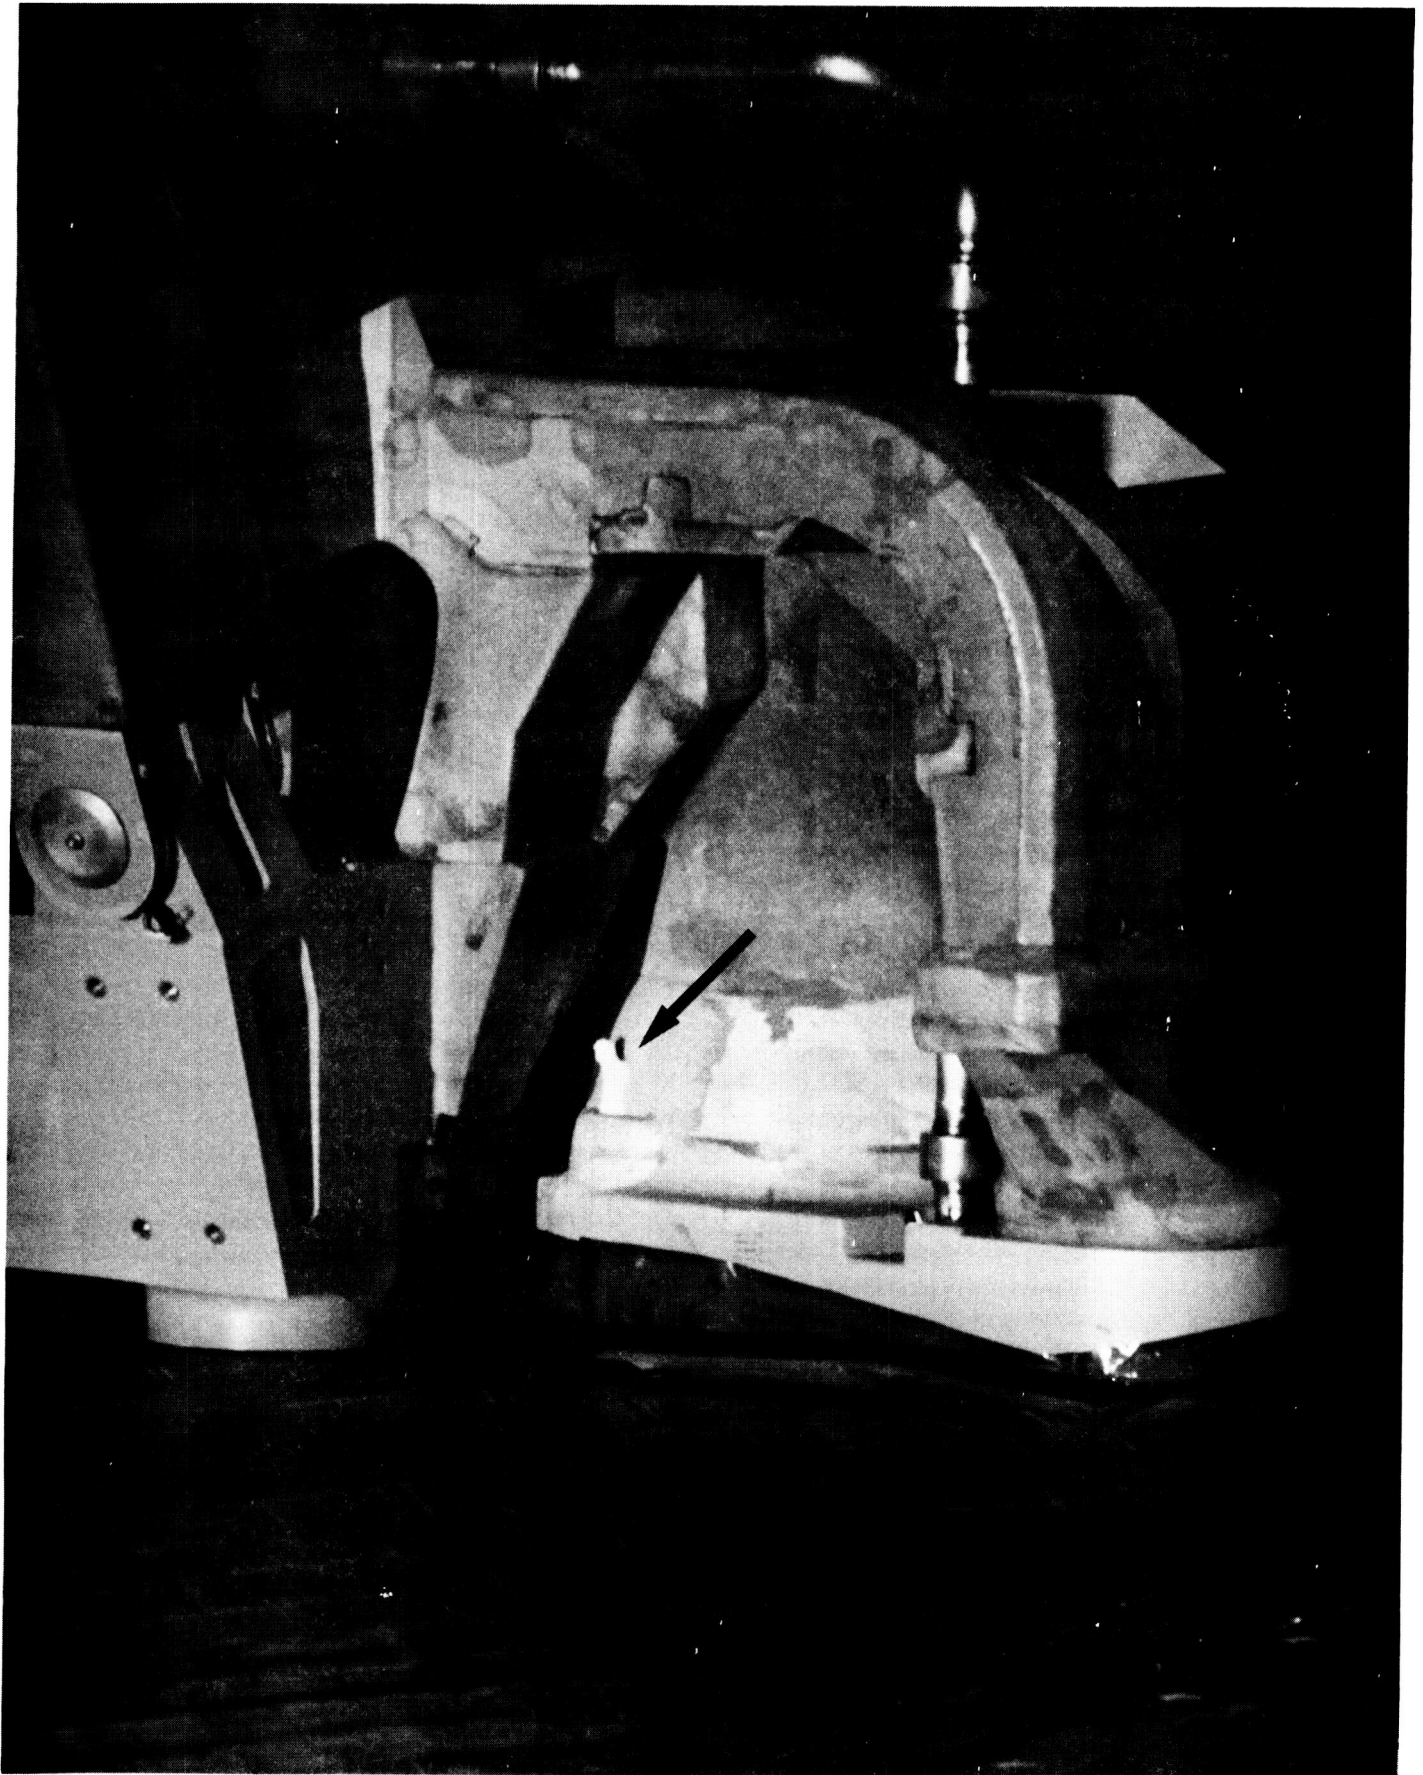
LIGHT ICE/FROST ACCUMULATION ON ET/ORB LO2 UMBILICAL.
TYPICAL FROST FINGER ON PURGE VENT.

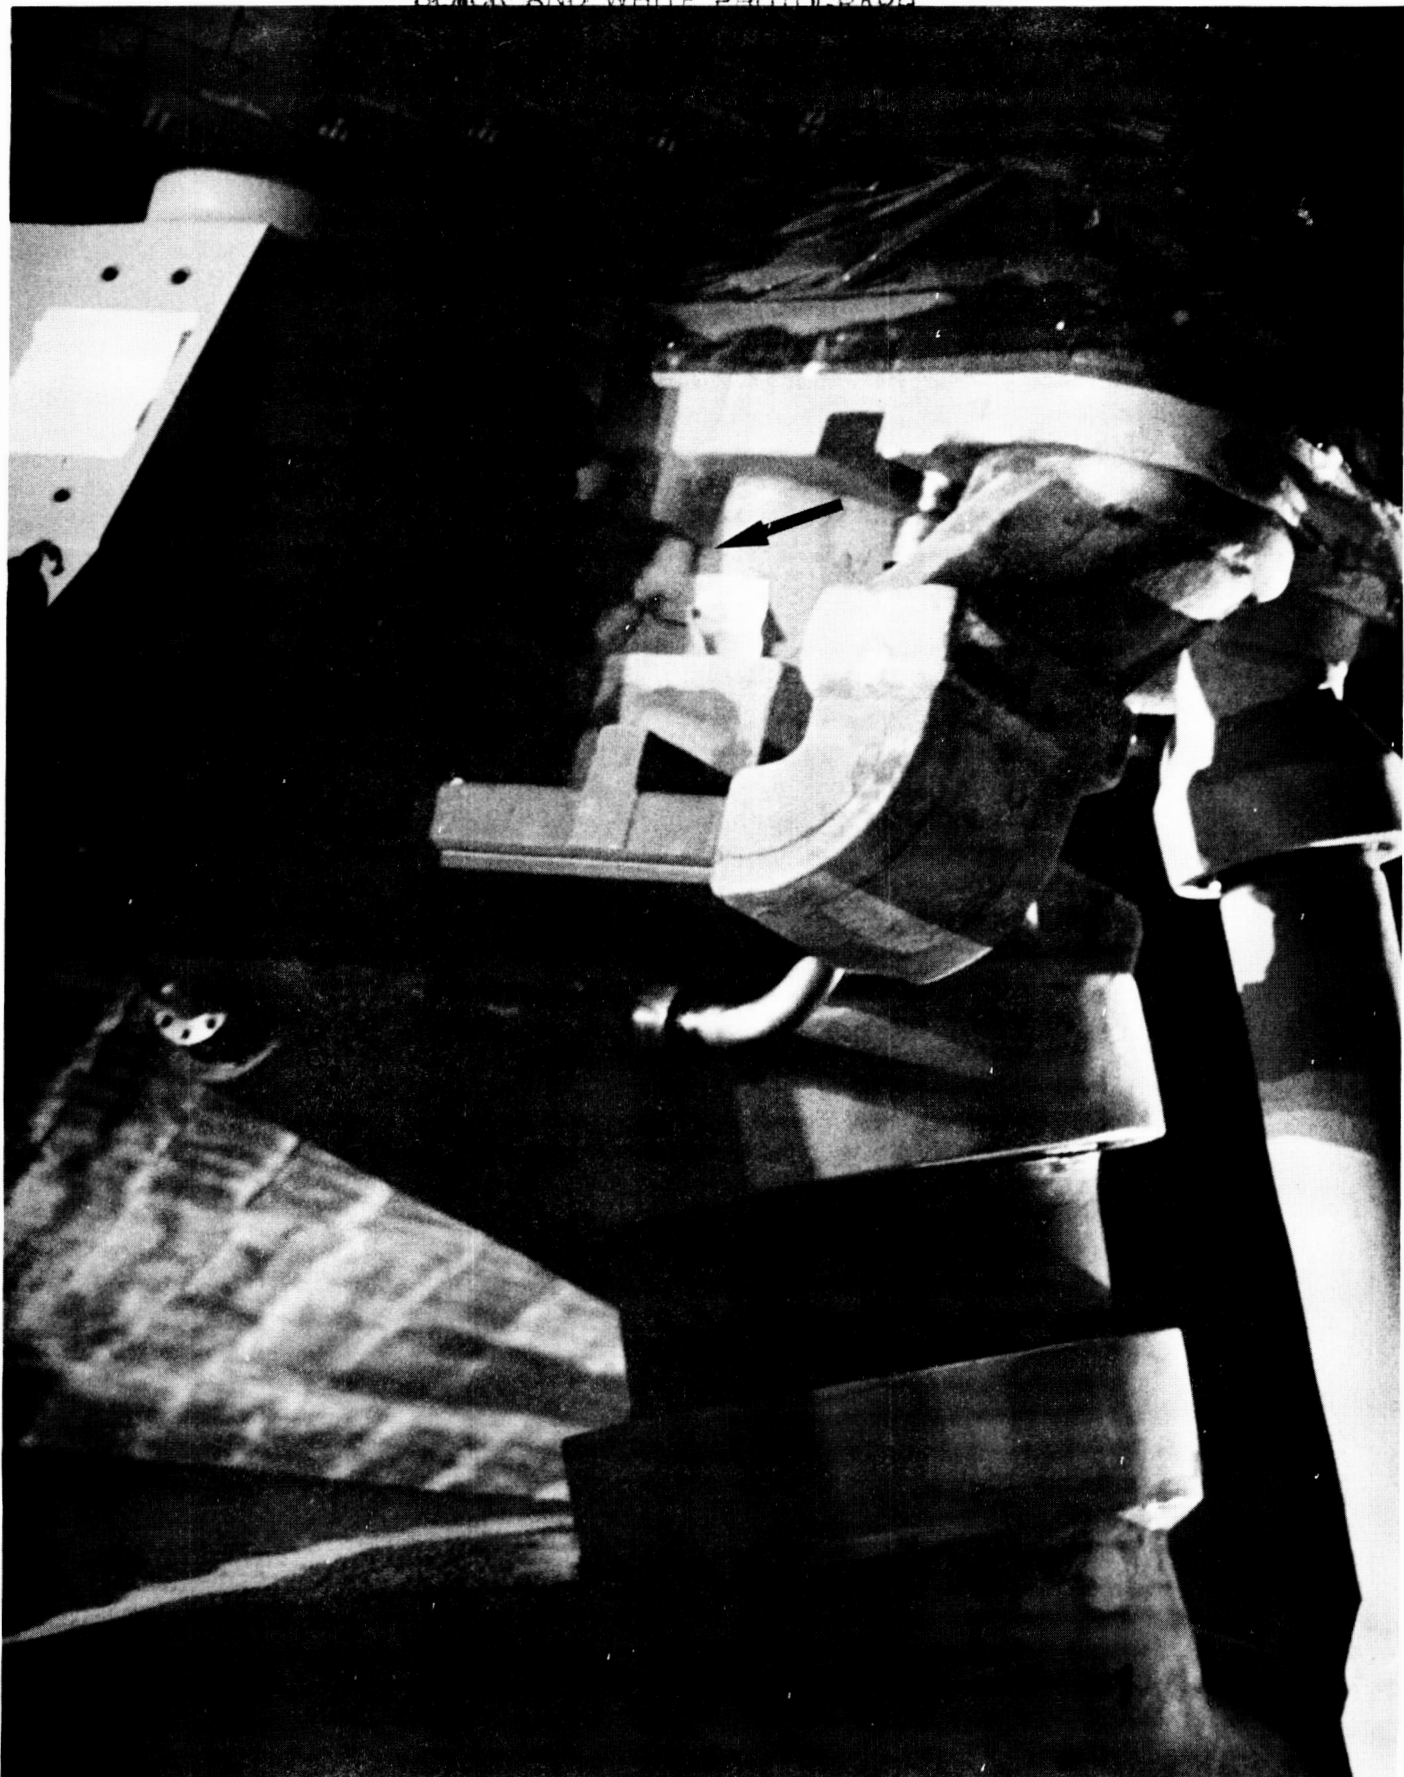
LIGHT ICE/FROST ACCUMULATION ON ET/ORB LH2 UMBILICAL.
TYPICAL FROST FINGERS HAVE DEVELOPED ON PURGE VENTS.

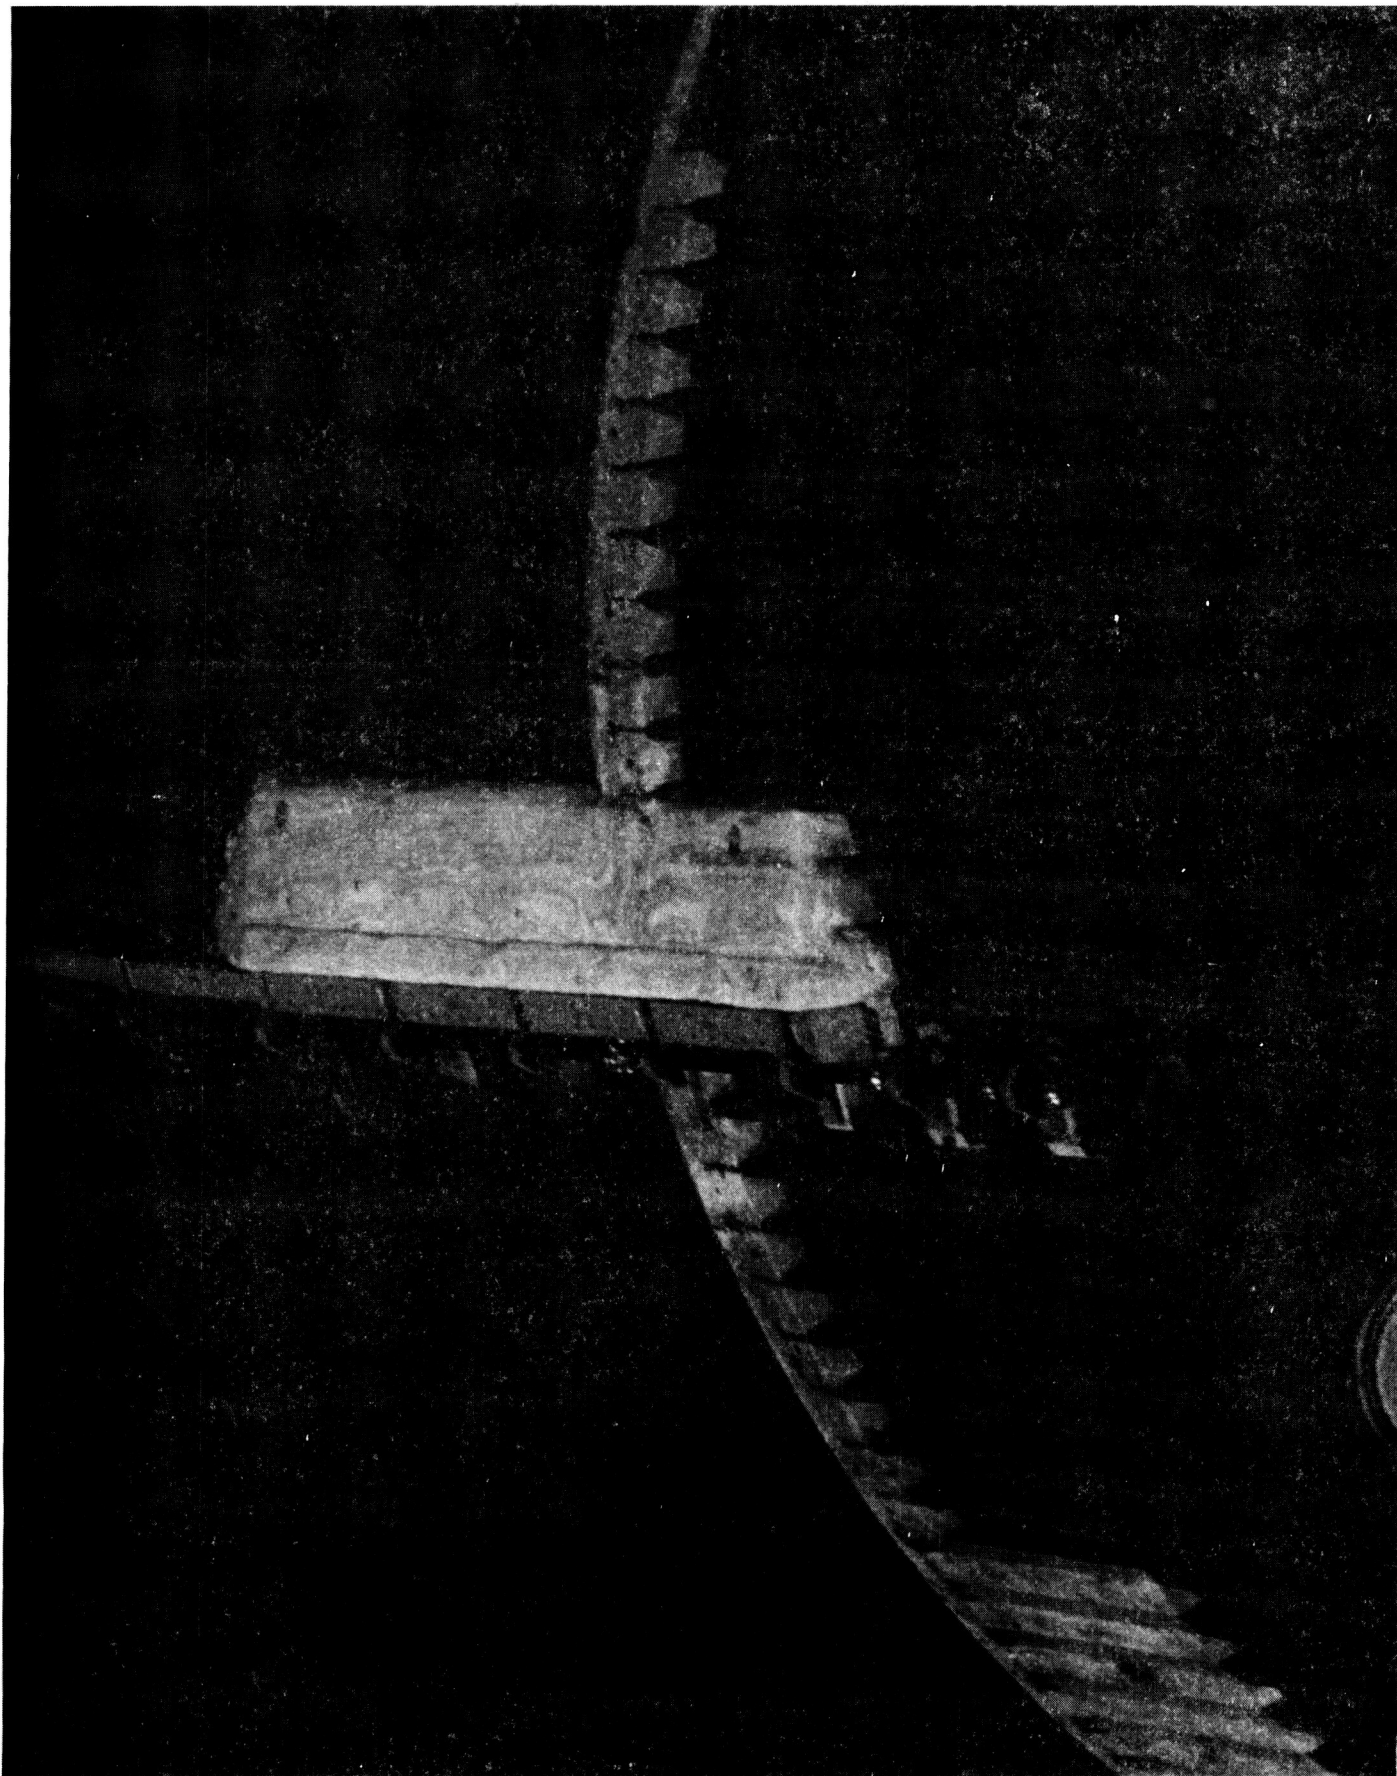
ET LO2 TANK PROTUBERANCE AIR LOAD (PAL) RAMP WITH UNIQUE
LONGITUDINAL REPAIR. NO ICE/FROST ON LO2 TANK BARREL SECTION.

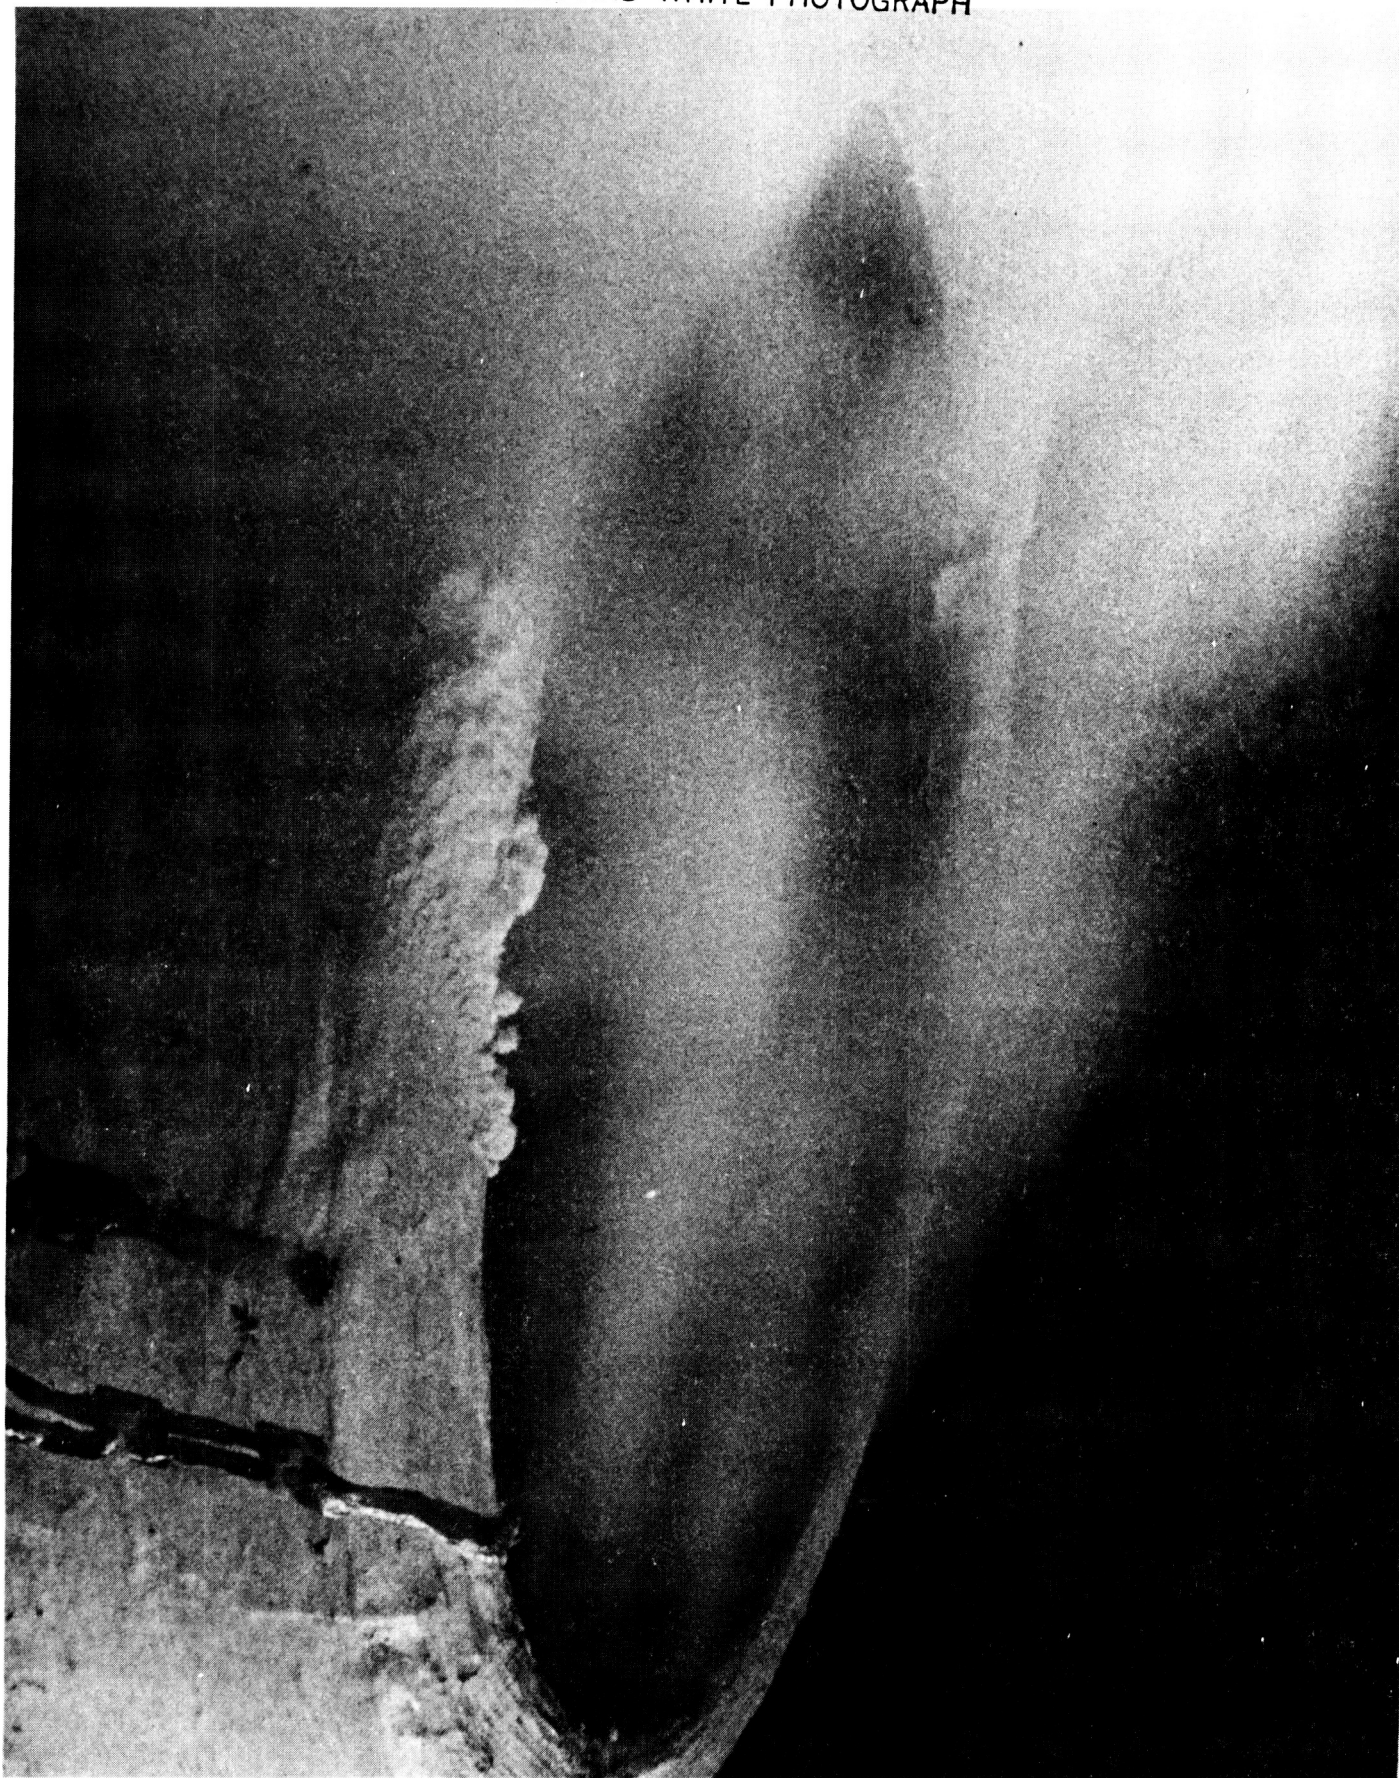
The formation of frost on the northern GOX vent exhaust duct was recorded on Anomaly 003 and IPR 27R-0493 was issued by CMEC. Most of the GOX vapors were flowing from the northern duct compared to no activity from the southern duct.

FROST FINGERS ON GOX VENT EXHAUST DUCT

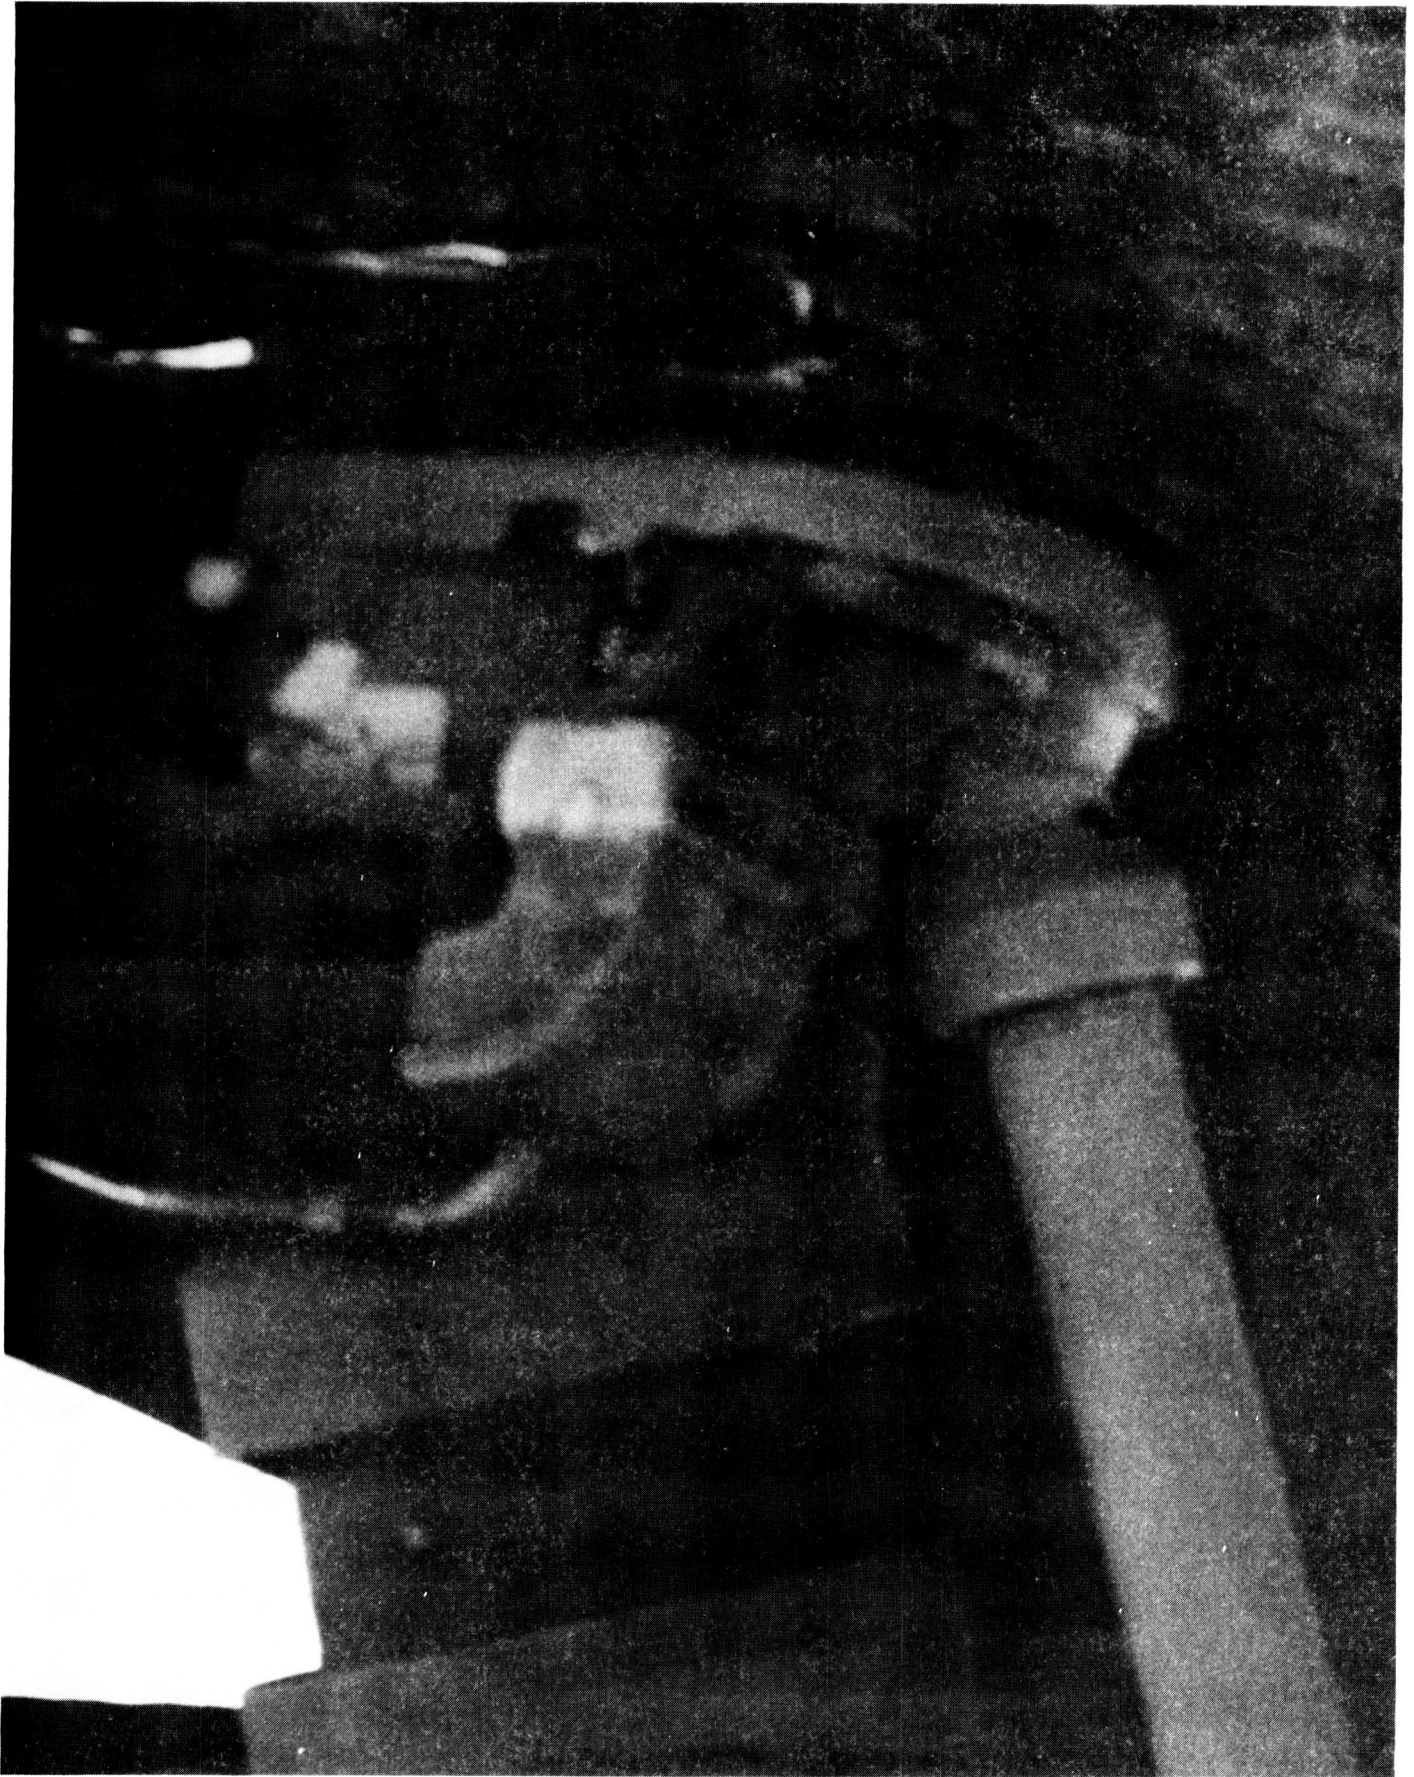
ICE/FROST STILL PRESENT ON ET/ORB LH2 UMBILICAL AFTER DRAIN

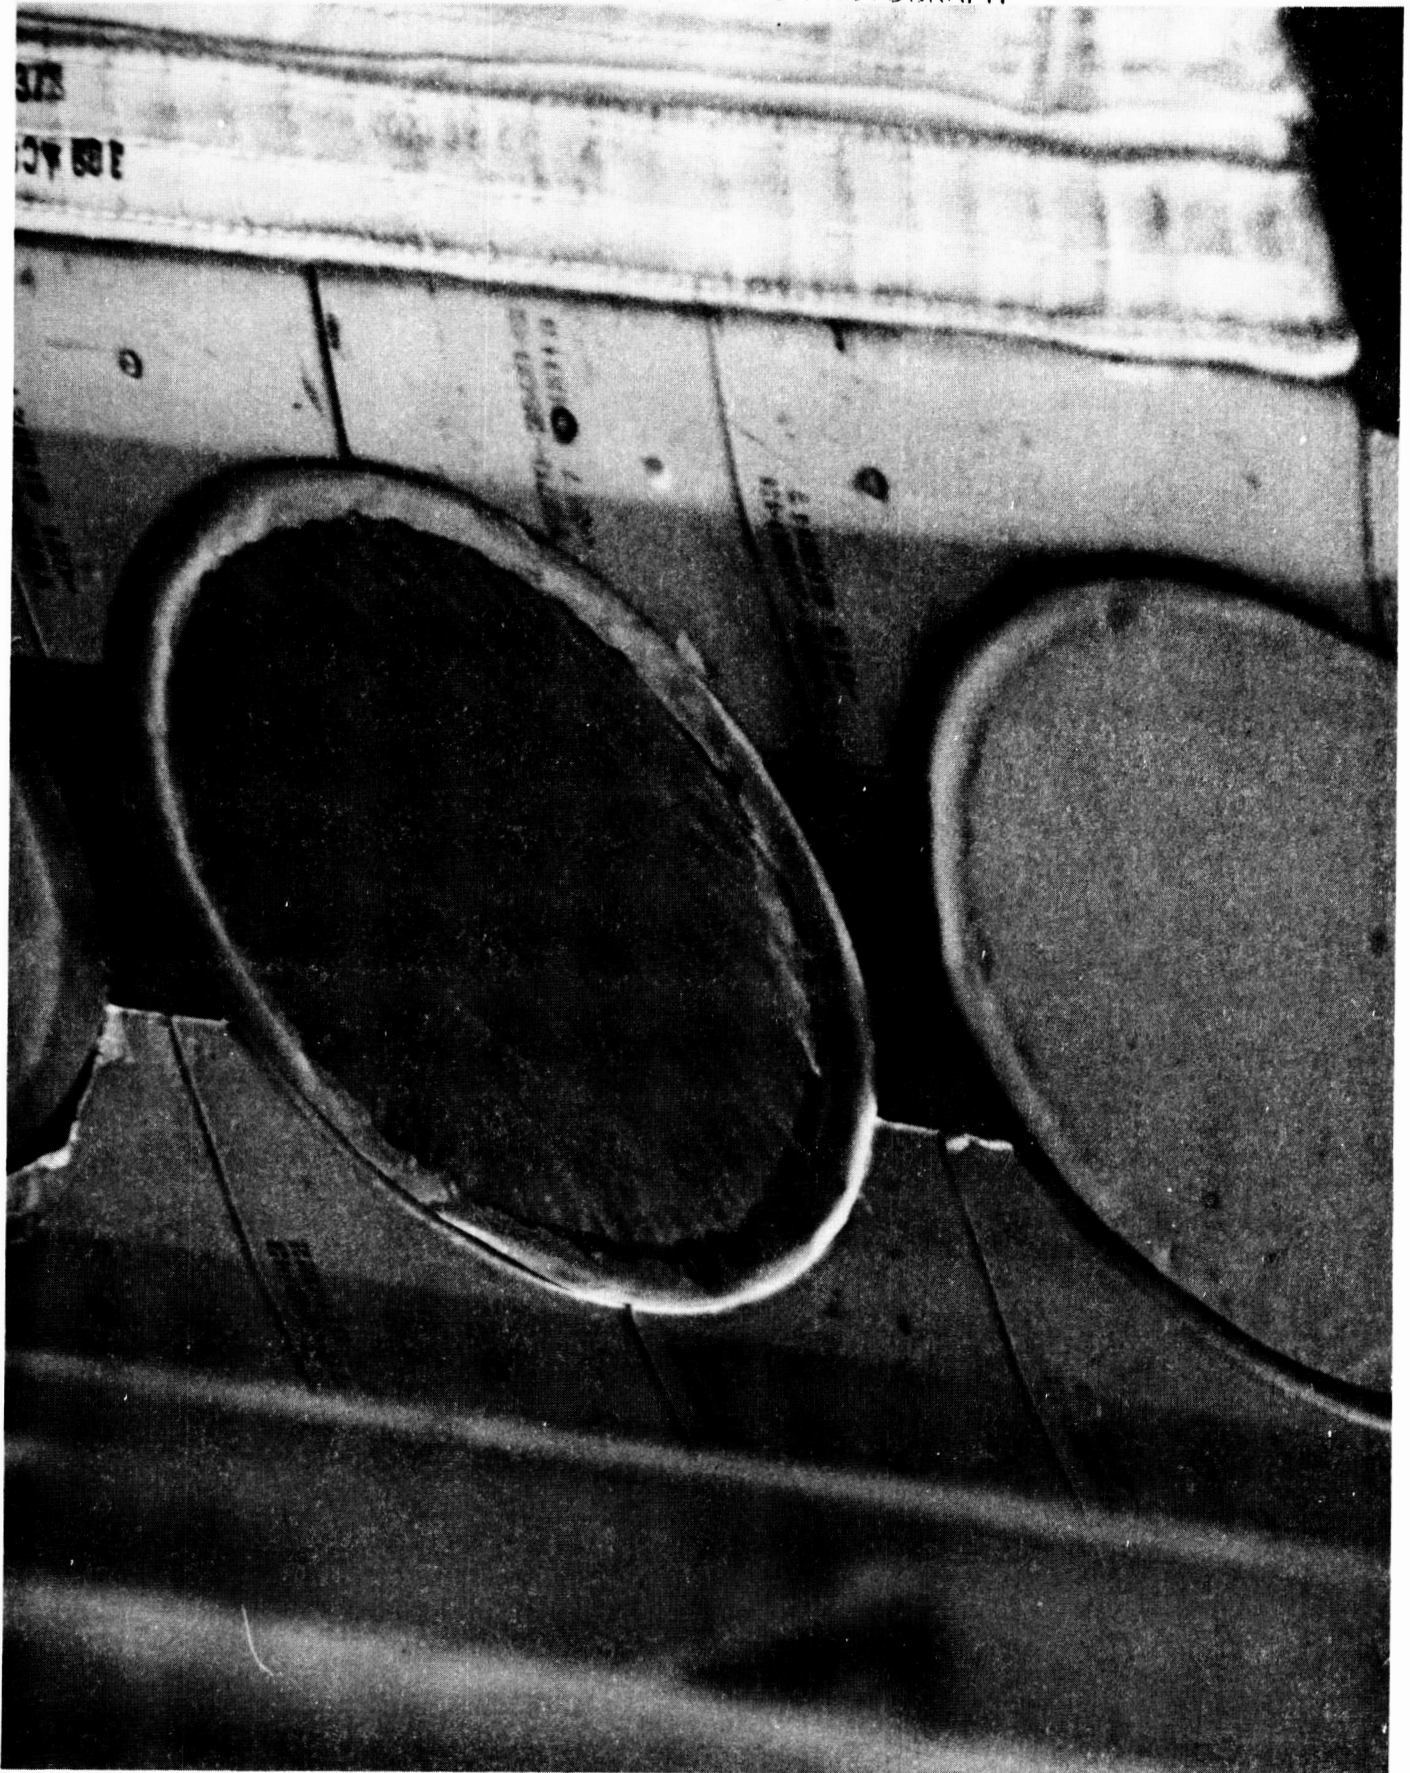
DISCOLORED RCS THRUSTER BUTCHER PAPER
COVER ON -Y SIDE OF LH OMS POD STINGER

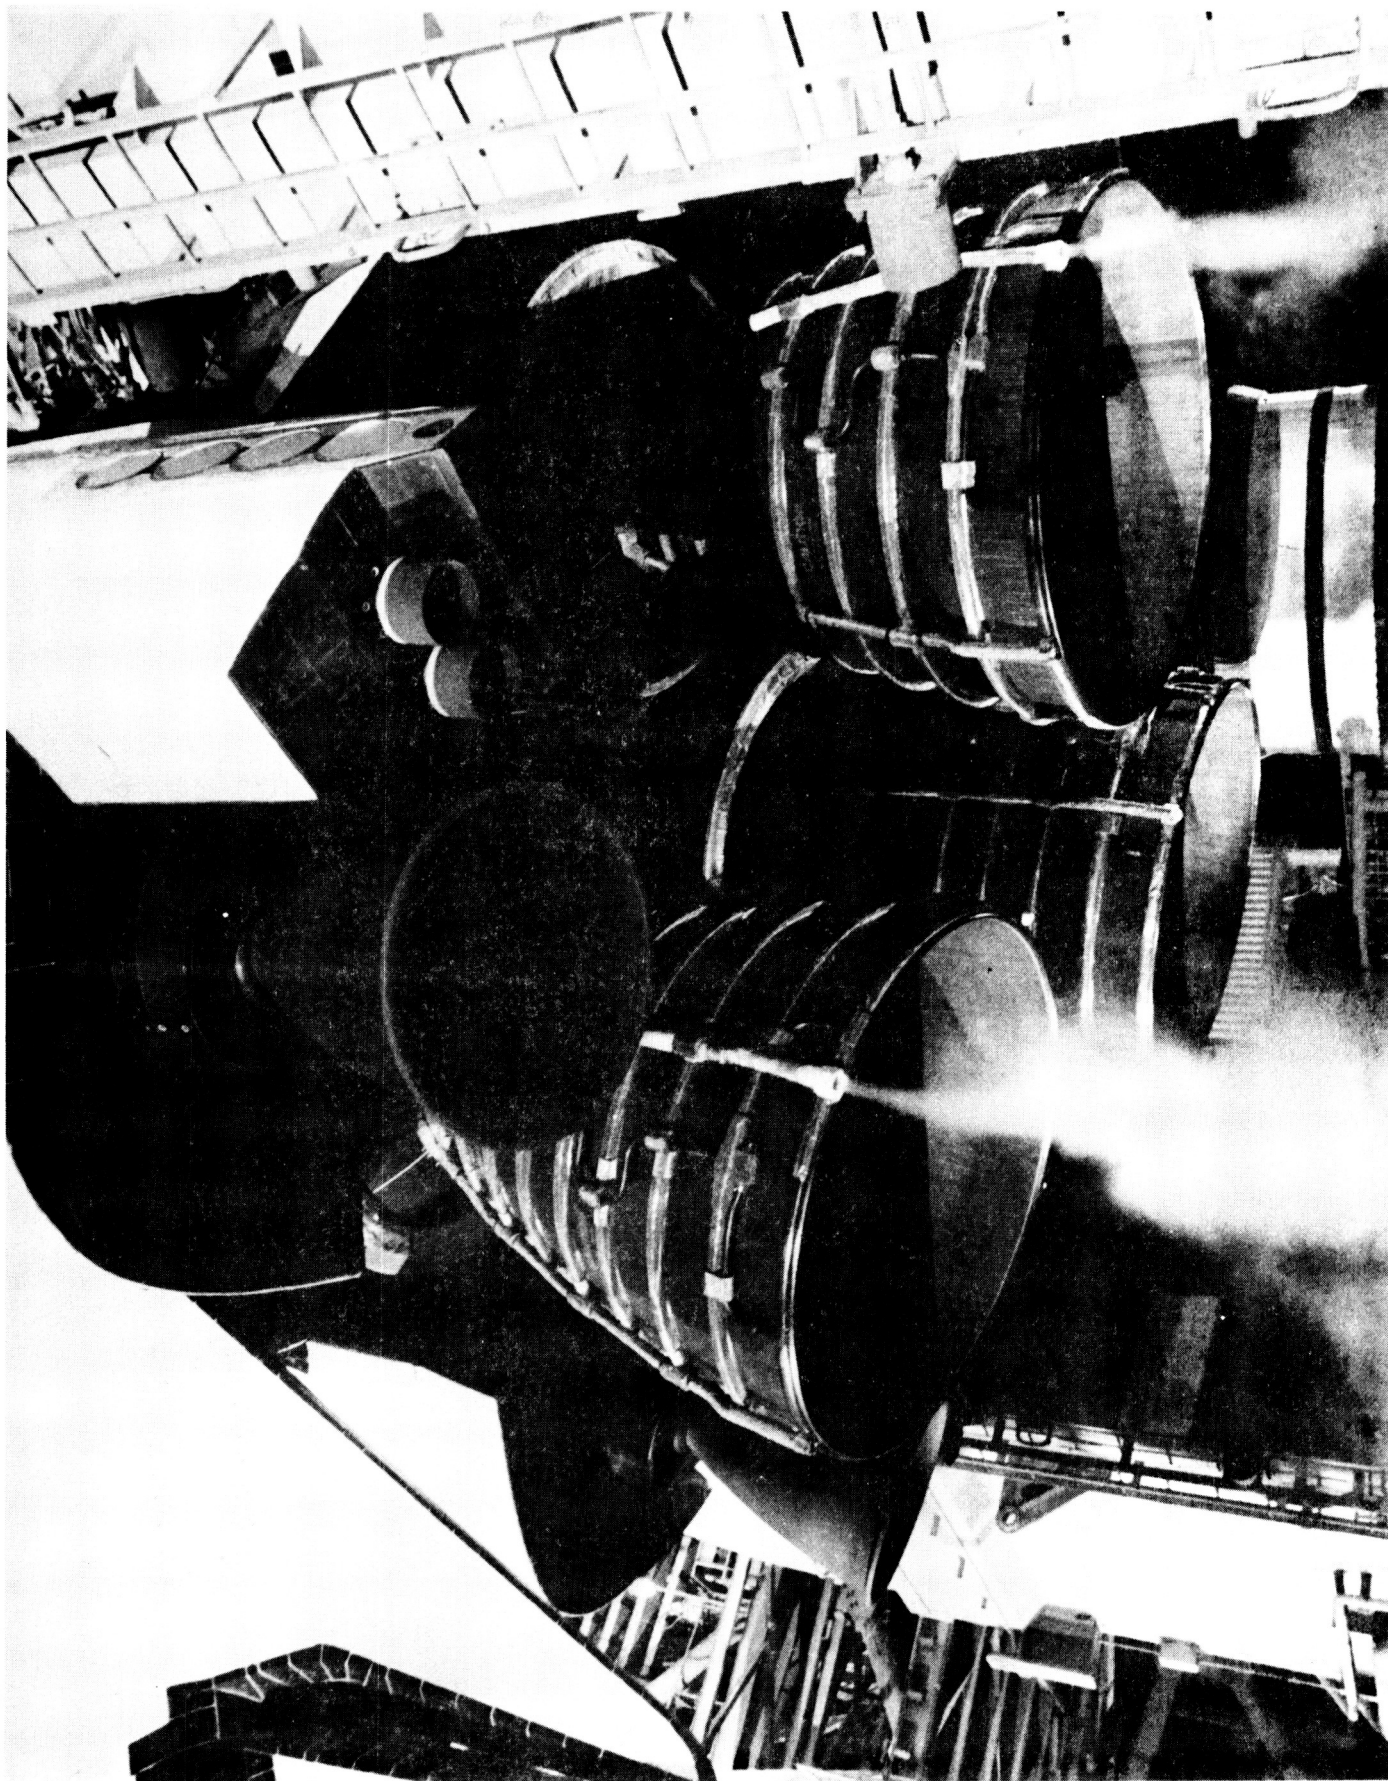
LIGHT FROST BUILD-UP ON SSME GOX VENTS
